**DEPARTMENT OF TRANSPORTATION**

Contract #: 04-0120F4Cty: SF/ALA Rte: 80 PM: 13.2/13.9File #: 69.28**WELDING INSPECTION REPORT****Resident Engineer:**Pursell, Gary**Address:** 333 Burma Road**City:** Oakland, CA 94607**Report No:** WIR-013010**Date Inspected:** 26-Mar-2010**Project Name:** SAS Superstructure**OSM Arrival Time:** 1900**Prime Contractor:** American Bridge/Fluor Enterprises, a JV**OSM Departure Time:** 700**Contractor:** Zhenhua Port Machinery Company, Ltd (ZPMC), Changxing Island **Location:** Shanghai, China**CWI Name:** See Below**CWI Present:** Yes No**Inspected CWI report:** Yes No N/A**Rod Oven in Use:** Yes No N/A**Electrode to specification:** Yes No N/A**Weld Procedures Followed:** Yes No N/A**Qualified Welders:** Yes No N/A**Verified Joint Fit-up:** Yes No N/A**Approved Drawings:** Yes No N/A**Approved WPS:** Yes No N/A**Delayed / Cancelled:** Yes No N/A**Bridge No:** 34-0006**Component:** OBG**Summary of Items Observed:**

## WELDING INSPECTION REPORT

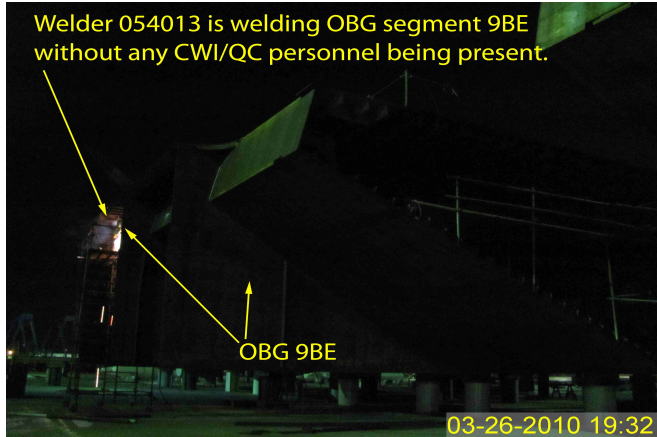
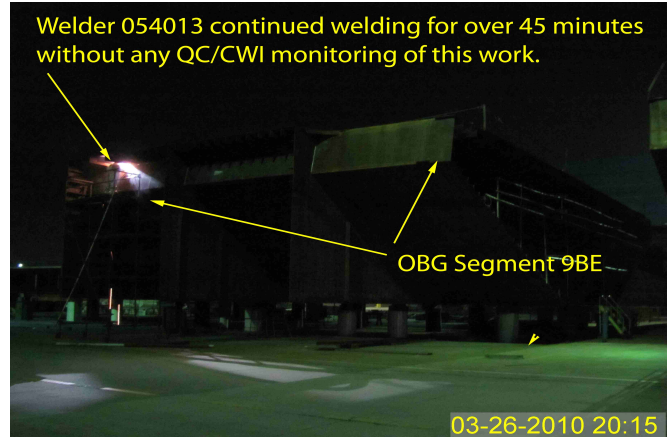
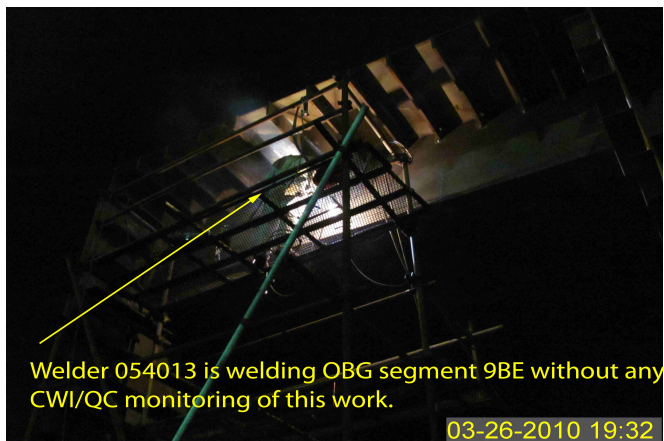
Yard between Bay 17 and blast shop #2

This QA Inspector observed ZPMC welder Mr. Kua Wen Shau, stencil 054013 is using shielded metal arc process to make weld SEG052E-022 and other adjacent welds near where segment SEG9BE will be connected to cross beam CB11. This activity is taking place on the top of a scaffold in the yard between bay 17 and blast shop #2. This QA Inspector observed no QC personnel appeared to be working near this location from the hours of 19:30 through 20:15. The Caltrans Special Provision Section 8-3.01 states: "QC inspections shall be provided to ensure continuous inspection when any welding is being performed. Continuous inspection, as a minimum, shall include (1) having QC Inspectors continually present on the shop floor or project site when any welding operation is being performed, and (2) having a QC Inspector within such close proximity of all welders or operators so that inspections by the QC Inspector of each operation, at each welding location, shall not lapse for a period exceeding 30 minutes." At around 20:20 hours this QA Inspector went to OBG Bay 14 and informed ZPMC QC Inspector Mr. Lu Liqing that no QC Inspectors appear to be monitoring Mr. Kua Wen Shau as he is welding segment 9BE. Mr. Lu Liqing informed this QA Inspector that he is not aware that anyone is welding at this location. Mr. Lu Liqing accompanied this QA Inspector to OBG segment 9BE and observed Mr. Kua Wen Shau was continuing to perform welding on segment 9BE stiffener plates. This QA Inspector asked Mr. Lu Liqing to phone ZPMC CWI Mr. Wang Xu and ask him to come to segment 9BE. Approximately ten minutes later Mr. Wang Xu arrived and this QA Inspector informed him that an incident report is being issued to document welding without CWI /QC personnel performing monitoring of this activity. See the photographs below for additional information.
